**DEPARTMENT OF TRANSPORTATION**

Contract #: 04-0120F4Cty: SF/ALA Rte: 80 PM: 13.2/13.9File #: 69.28**WELDING INSPECTION REPORT****Resident Engineer:**Siegenthaler, Peter**Address:** 333 Burma Road**City:** Oakland, CA 94607**Report No:** WIR-024091**Date Inspected:** 24-May-2011**Project Name:** SAS Superstructure**OSM Arrival Time:** 700**Prime Contractor:** American Bridge/Fluor Enterprises, a JV**OSM Departure Time:** 1900**Contractor:** Zhenhua Port Machinery Company, Ltd (ZPMC), Changxing Island **Location:** Shanghai, China**CWI Name:** An Qing Xiang**CWI Present:** Yes No**Inspected CWI report:** Yes No N/A**Rod Oven in Use:** Yes No N/A**Electrode to specification:** Yes No N/A**Weld Procedures Followed:** Yes No N/A**Qualified Welders:** Yes No N/A**Verified Joint Fit-up:** Yes No N/A**Approved Drawings:** Yes No N/A**Approved WPS:** Yes No N/A**Delayed / Cancelled:** Yes No N/A**Bridge No:** 34-0006**Component:** OBG**Summary of Items Observed:**

OBG Segment 14E

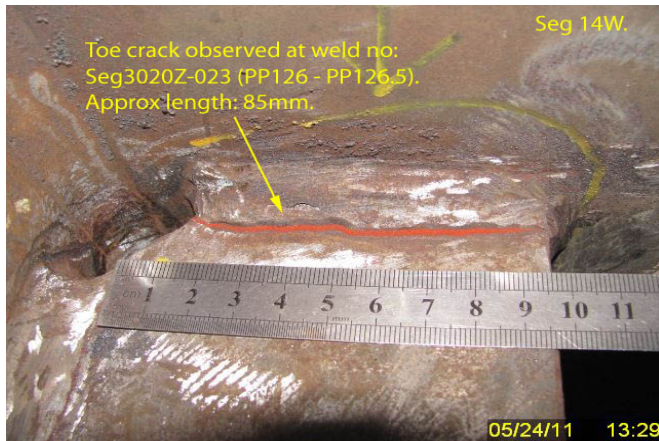
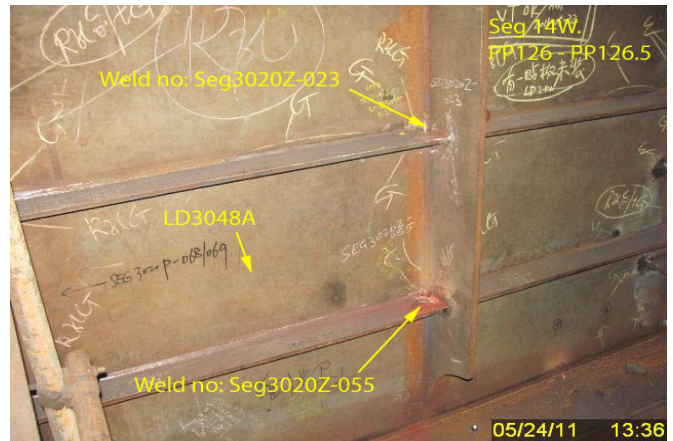
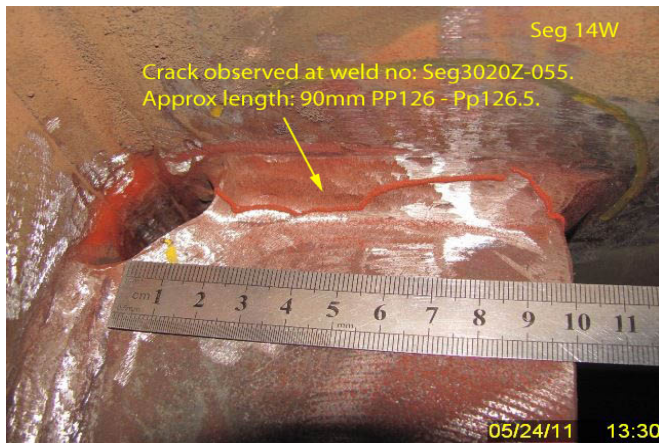
This QA Inspector, along with Mr. Shailesh Wadkar; performed in process Visual Inspection of welds (Segment 14W) at Panel Points (PP) 126 to PP 127. Visual Inspection was performed on the welds between Longitudinal Diaphragm (LD) 3050A to LD 3048A (on the welds inside of the Segment). At two locations stiffener on LD to FB welds, this QA Inspector observed to have toe cracks. Details are as follows:

SEG3020Z-023, 055

This QA Inspector informed to ZPMC CWI, identified as Mr. An Qing Xiang. The weld locations were documented and forwarded to the CT Lead QA Inspector for further disposition. See attached photos for more details.
